Troubleshooting

This section lists common issues that may occur during the installation or operation of SMHUB and their solutions.

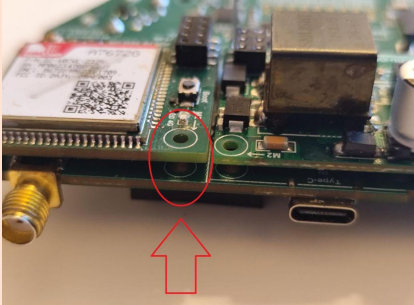
The first batch of SMHUBs with 4G add-ons did not include the screw with a ring, which was meant to be placed between the add-on and the main PCB.

For some users, this caused a short circuit that prevented the hub from turning on. To fix this, follow the steps below:

1. Remove the 4G add-on
2. Stick insulating tape to the SIM card slot or place a layer of paper between the PCB and the 4G add-on

3. Install the 4G add-on
