Troubleshooting

This section lists common issues that may occur during the installation or operation of SMHUB and their solutions.

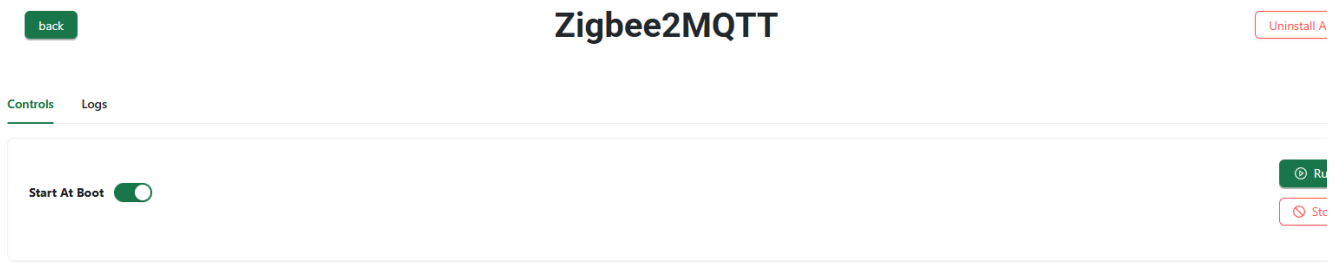
6. Go to "Apps" -> "Zigbee2MQTT" and press "Run" button

2. Type: `cd /opt/zigbee2mqtt/data`
3. (optional) Type: `ls` to show filelist
4. Type `rm coordinator_backup.json`
5. (optional) Type: `ls` to show updated filelist

7. Now you can go to the Z2M interface, it will launch soon
